Monitoring Data Record

Project Title: <u>R-2248D – Charlotte Outer Loop</u>	COE Action ID: <u>200131321</u>
Stream Name: <u>Trib. to Dixon Branch (Site 16)</u>	DWQ Number: <u>011231</u>
City, County and other Location Information: <u>Mecklenburg County, Charlotte Outer Loop, R-2248D Right of Project Station 13+50 Ramp 2D</u>	
Date Construction Completed: <u>February 2005</u>	Monitoring Year: (<u>3</u>) of <u>5</u>
Ecoregion: _____	8 digit HUC unit <u>03050103</u>
USGS Quad Name and Coordinates: _____

UT to Dixon Branch

Year 3 Summer – September 2011

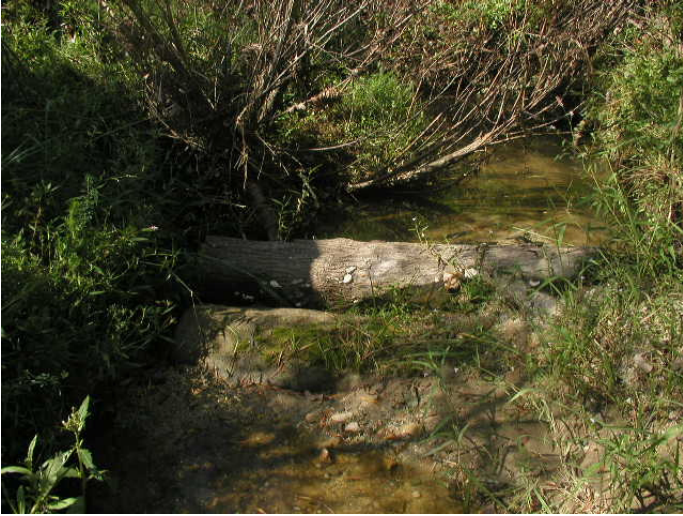
Log Sill #1 (looking downstream)

This completes the Year 3 Summer evaluation for the UT to Dixon Branch (Site 16) stream relocation. NCDOT installed log sills in May 2010 to stop the previously noted headcut and further stabilize the stream. Three of the four installed log sills have water piping under or around these structures at the time of the monitoring evaluation but sediment deposited from upstream onto the site have improved these log sills. The sediment has filled in some of the voids in and around these log sills. A headcut previously noted has filled in due to the deposited sediment onsite. NCDOT will continue to monitor for channel stability at this stream relocation.

Date 9/12/11	Between PP#1 and PP#2	Station Number	Station Number	Station Number	Station Number
Structure Type	Log Sills				
Is water piping through or around structure?	Water is piping under or around three of the four installed log sills				
Head cut or down cut present?					
Bank or scour erosion present?					
Other problems noted?
